# CASE STUDIES

## Pulp And Paper: Conveyor Transfer Point Installation

### The Fundamentals of a Clean, Safe, and Efficient Conveyor

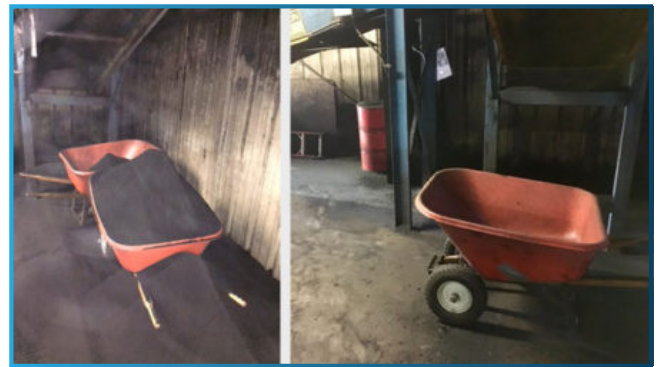
The coal transfer tower at the plant experienced substantial volumes of turbulent air when the coal moved from the crusher to conveyor. This resulted in pressurized airborne dust escaping the transfer point and covering the surrounding area. Workers filled wheelbarrows several times a day with the powdery dust that covered the floor, railings, and all nearby surfaces. Sweeping and daily clean up were consuming an increasing amount of worker time and effort. In addition, escaping material caused rapid skirt wear, belt mis-tracking, and other conveyor maintenance problems. Finally, the fugitive material created an unsafe environment for workers.

AIRMATIC Application Specialists concluded MARTIN® conveyor products would eliminate the problems. First, AIRMATIC installed a belt support system to prevent the belt from sagging. Sagging belts allow fugitive material to escape along the sides of the belt line. Next, belt tracking devices were installed on both the carrying and return sides of the belt to reduce alignment problems. To better contain the material, a double-lip, self-adjusting skirting was installed to replace the existing skirting and keep the edge sealed. Abrasion-resistant wear-liners were installed inside the transfer point skirt-board to prolong the life of the seal. Finally, a high volume “passive” dust settling zone with multiple dust-trapping curtains was installed on top of the existing chute walls to reduce air velocity. This solution enabled dust from the conveyed coal to settle, allowing cleaner air to exit the chute.
