CASE HISTORY

**FOUNDRY CONVEYOR TRANSFER
POINT REENGINEERED**
Material Loss Eliminated; \$160,000 + Saved Over 5 Years

Conveyor Transfer Point Cleanup

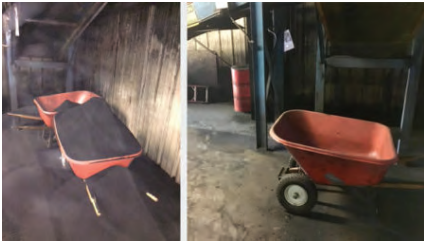
An Aluminum Foundry in Eastern, PA experienced an ongoing issue affecting production efficiency and worker morale. For years, workers needed to position wheelbarrows under a Transfer Point to catch foundry-sand spillage. Workers needed to empty the wheelbarrows multiple times each day. The problem not only added to the workload, but also created environmental hazards and morale issues. By the time the Foundry could address the problem, it was costing \$32,000 per-year to clean up the spillage. Having worked with AIRMATIC on previous projects, this Foundry knew the Company would have the knowledge, products, and installation capabilities to solve the problem. Upon inspection, AIRMATIC Application Specialists quickly discovered the distribution belt was loading the receiving belt too close to its tail-end. Loading so close to the tail caused belt-vibration and excessive belt-movement along the belt-line. In addition, the existing Transfer Chute structure was oversized for the receiving belt causing overloading and material spillage along the length of the conveyor. Finally, without primary belt-cleaners installed on the distribution belt's head pulley, foundry-sand would carryback and fall in piles of material along the entire return-run.

Following CEMA® guidelines and utilizing the MARTIN® FOUNDATIONS™ SOTA approach to belt conveyors, AIRMATIC Application Specialists determined the Transfer Point needed to be re-engineered to cleanly transfer the sand. The first step was to remove the existing chute. Next, AIRMATIC extended the tail end of the receiving belt by four feet. Doing so allowed the tail pulley to be pushed back and away from the incoming sand. Furthermore, moving the tail pulley helped stabilize the belt line which increased belt-life, and enabled the installation of a MARTIN® Tail-Box System to prevent material spilling off the tail of the conveyor. New chute walls, installed 3/4-inch above the belt-line—according to CEMA® guidelines—and positioned so as to load material centrally on the belt allowing the material to take on a symmetrical profile on the receiving conveyor and thereby minimize the potential for tracking problems and spillage. To eliminate belt bounce, AIRMATIC installed a wrapped, chevron-style head-pulley that maintains continuous contact with the belt to not only prevent punctures by deflecting fugitive material away, but also reduce noise by 50 dBA. An idler conversion kit with support bars eliminated all belt sag and ensured the new MARTIN® ApronSeal™ Skirting system would contain material and airborne dust where it is most prone to spillage. Finally, two primary belt-cleaners were installed at the distribution belt's head pulley, effectively eliminating carryback.
