# Feed Mill: Automatic Lubrication System Installation

**Bucket Elevator Maintenance Cut By 85%**

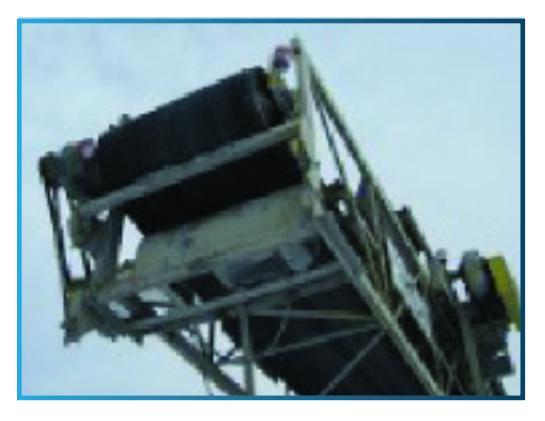
This job story looks at the benefits of using an automatic lubrication system instead of manual lubrication in a New England feed mill. The mill employs a bucket elevator with two bearings supporting the head pulley at the top of a vertical bulk conveyor. The elevator lifts various grain products an estimated 40 feet in the air to the top of a silo storage system. There, the grain is distributed to various silos for blending into specific animal feed mixes. Lubrication is especially important on this equipment because the weight of the entire conveying system and the grain being lifted rests on the head pulley and its two bearings.

AIRMATIC Application Specialists surveyed the situation and determined the solution to this problem was to install two ATS ELECTRO-LUBE'S ULTIMATE LUBER<sup>™</sup> Automatic Lubricators, one on each of the two bearings supporting the head pulley. The lubricators automatically dispense consistent lubrication over long intervals, applying constant pressure and positive lubrication on the bearing points, to not only keep moisture and other contaminants out of the bearing but also ensure that only the precise amount of lubricators are transparent and have LED indicators, both lubricant levels and operating status can be easily checked by operators and inspectors from the floor.
