CASE HISTORY

FEED MILL: AUTOMATIC LUBRICATION SYSTEM INSTALLATION *Bucket Elevator Maintenance Cut By 85%*

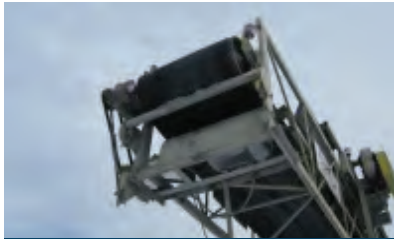
*Automatic Lubrication System on
Head Pulley of Belt Conveyor*

AIRMATIC Application Specialists surveyed the situation and determined the solution to this problem was to install two ATS ELECTRO-LUBE's ULTIMATE LUBER™ Automatic Lubricators (one on each of the two bearings supporting the head pulley.) The lubricators automatically dispense consistent lubrication over long intervals, applying constant pressure and positive lubrication on the bearing points, which not only keeps moisture and other contaminants out of the bearing but also ensures that only the precise amount of lubricant specified by the OEM is delivered (no "over-lubrication"). In addition, because the lubricators are transparent and have LED indicators, both lubricant levels and operating status can be easily checked by operators and inspectors from the floor. This solution allows for a more efficient operation and also prevents workers' safety from being compromised.
